# PROCES VULKANIZACIJE SILEN BLOKA U KOMPANIJI VORWERK

Hristina Aćimović<sup>1</sup>, dr Andelija Mitrović<sup>2</sup>

## PROCESS OF VULCANIZATION OF SILENT BLOCK IN VORWERK COMPANY

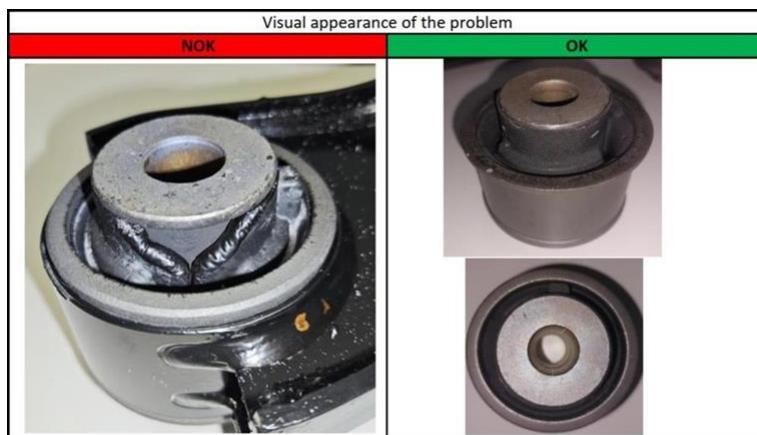
Kupac Beycelk Gestemb Chassiss je prijavio neizliven deo (slika 8). Potrebno je vizuelno proveriti da li je deo u potpunosti izliven sa obe strane lagera.

Slika 8: Vizuelni prikaz neulivenog dela

Alat poseduje 5 tool tempova (TT). Došlo je do pogrešnog povezivanja creva na TT sa alatom na zoni gde se nalaze dizne. Do ovoga je došlo jer operater nije imao obeležena creva sa oznakama „ULAZ/IZLAZ“. Iz tog razloga se smatra da je došlo do zamene creva na TT. Pogrešnim povezivanjem creva, poremećen je tok ulja u alatu, a samim tim i temperature, što je dovelo do vulkanizacije dizni, i kasnije do neulivenih delova. Preuzeta akcija, u ovom slučaju, je postavljanje oznaka na crevima. Pravilna oznaka creva „ULAZ/IZLAZ“ prikazana je na sledećoj slici (slika 9).

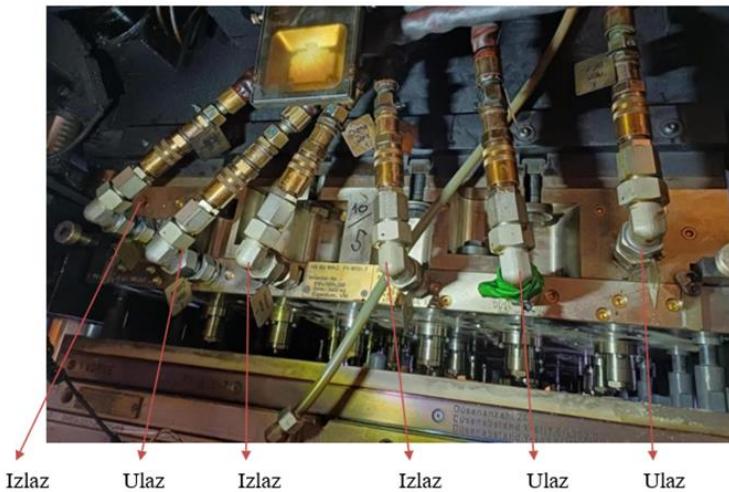
Slika 9: Prikaz pravilne oznake creva „ULAZ/IZLAZ“

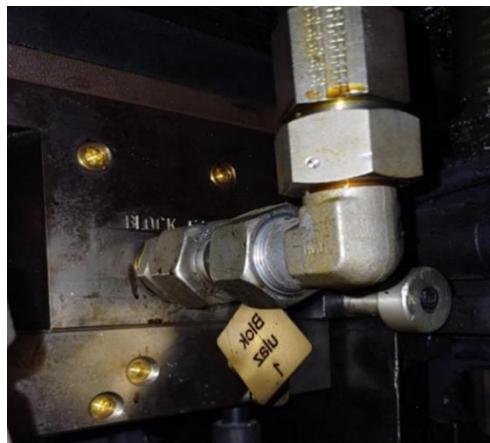
Slika 11: Pločica za obeležavanje dizni

Prikaz realizacije, tj. obeležene dizne prema datoj instrukciji je prikazan u nastavku (slika 11).
